**CHEMUNG RIVER BASIN  
WAVERLY LOWER  
RESERVOIR DAM  
TIOGA COUNTY, NEW YORK  
INVENTORY NUMBER NY 623**

**PHASE 1  
INSPECTION REPORT  
NATIONAL DAM  
SAFETY PROGRAM**

**L. ROBERT KIMBALL and ASSOCIATES  
615 W. Highland Ave. Ebensburg, Pa.**

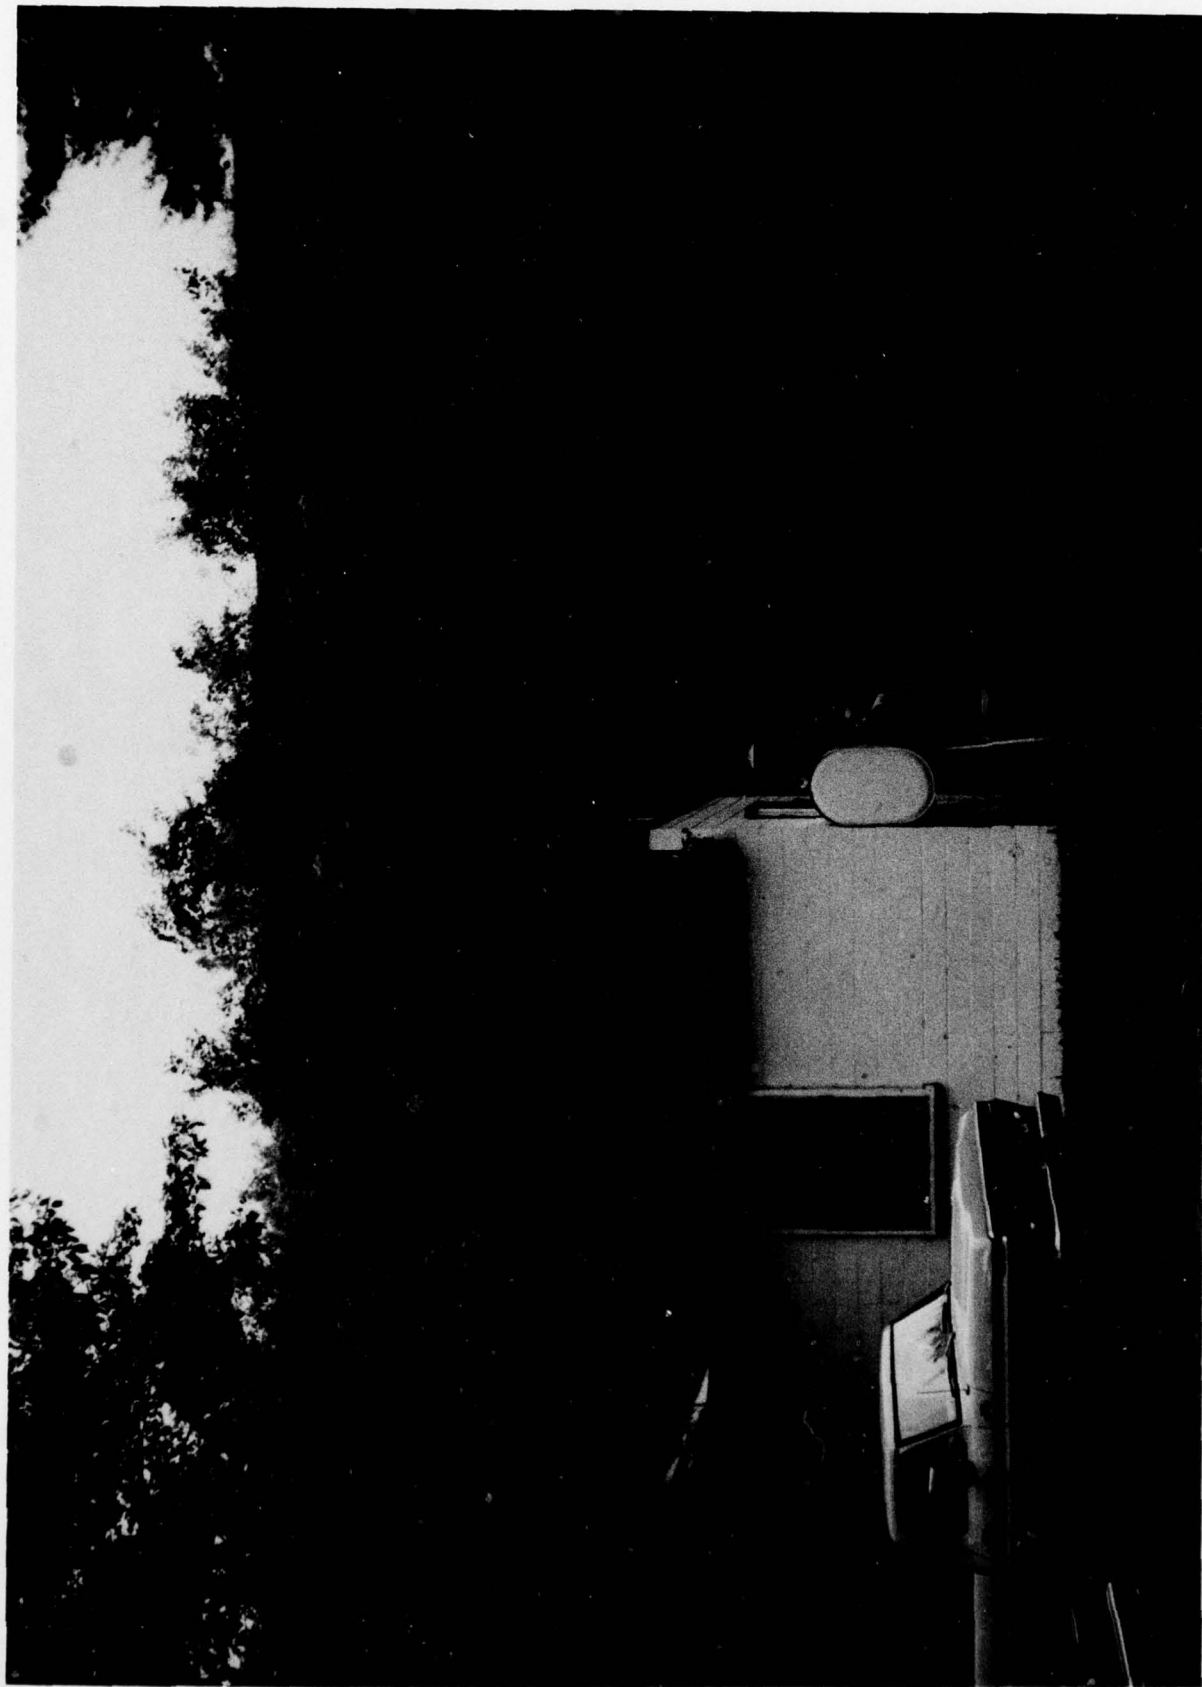
PLATE 4

The upstream slope is relatively steep and the crest narrow. No slumping, bulging or cracking was observed however, the vegetation and rock on the downstream slope may have concealed minor movement. Minor seepage was noted at the downstream toe apparently through the abutment rock which is closely beeded.

1. View of crest from left abutment looking toward spillway.
2. & 3. Upstream face.
4. Downstream slope, note valve house.
5. Emergency spillway crest weir in foreground.
6. Seepage around pipe inside valve house.
7. View of downstream slope of Upper Waverly Dam from crest of Lower Waverly Dam.
